New spillway provides much-needed water to ranchers and farmers

Lovelock, Nevada

Rodgers Dam - North Spillway

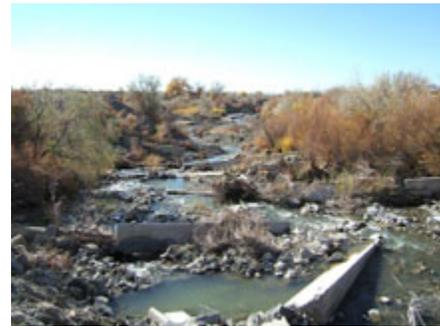
original spillway

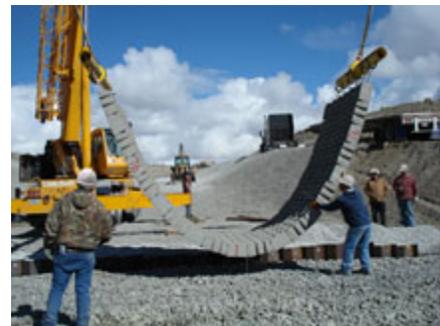
installation of ArmorFlex

CONTECH presented the [ArmorFlex](#) Class 70T, articulating mat option for the spillway. Using a hydraulic engineering center-river analysis system (HEC-RAS) model of the channel provided by DEC, CONTECH value engineered a solution that could withstand the 3000 cubic feet per second (cfs) discharge and handle sub grade settlement without compromising the structure.

A 50' wide concrete structure at the top of the spillway transitions down to a trapezoidal channel 72' wide at the top with a 40' wide bed. It takes water from the upper part of the reservoir and lets it go down 350' to the bottom of the riverbed. Based on the model, the water velocity coming down the spillway is in the 20 ft per second (fps) range which determined the use of 70-T ArmorFlex tapered series. The 24,000 ArmorFlex blocks are installed bank to bank over a geotextile suited for the very fine soil conditions. The 8' wide and 26' long ArmorFlex mats were lifted into place by a crane and set on a prepared sub grade.

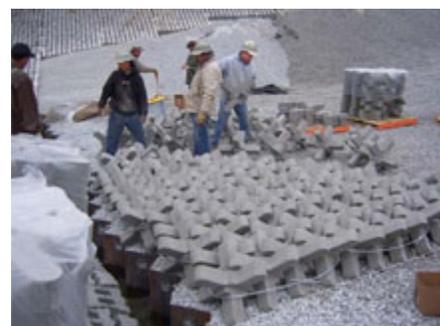
installation of A-Jacks

CONTECH recommended installing 24" [A-Jacks](#) the width of the spillway. The flow comes down the slope over the articulated ArmorFlex Class 70T. The water transitions to the flatter surface where it runs into a 38' long field of A-Jacks forcing a hydraulic

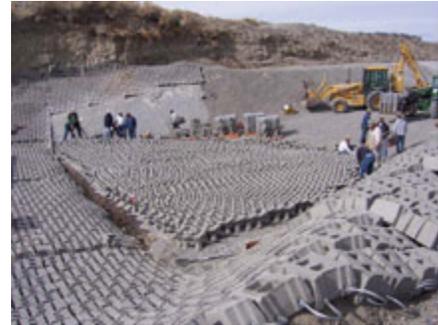
installation of A-Jacks continues

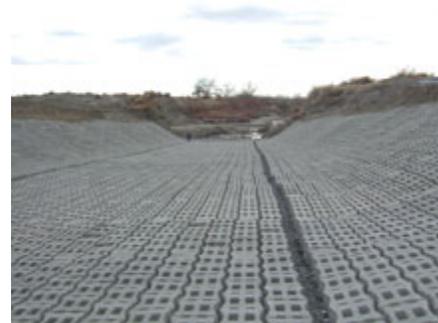
ArmorFlex installation complete

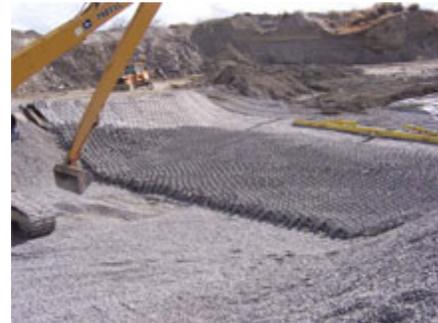
A-Jacks installation complete

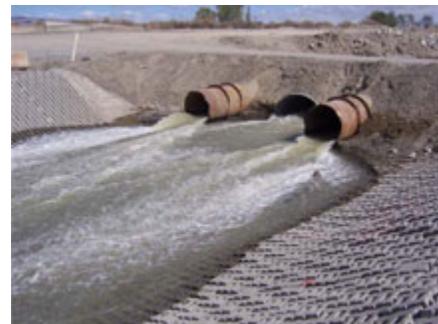
spillway complete

consists of a trapezoidal channel that has a top width of 72 feet, a bottom width of 40 feet, a depth of 10 feet, and a length of approximately 400 feet.

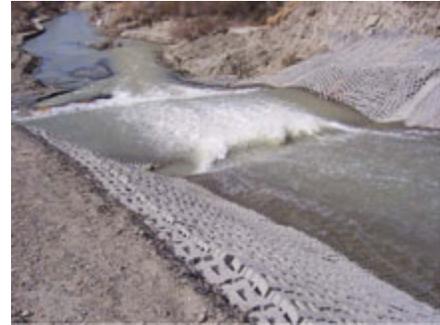
hydraulic jump

jump that brings the water down to a sub critical flow. The water velocity coming into the field of A-Jacks is 20 fps and CONTECH achieved 3 fps on the outlet. The target outlet velocity was 4 to 5 fps.
