OVERVIEW: Kentucky River Bank Stabilization, Frankfort, Kentucky

PRODUCT: A-JACKS AJ-24
Concrete Armor Units

OWNER: City of Frankfort, KY

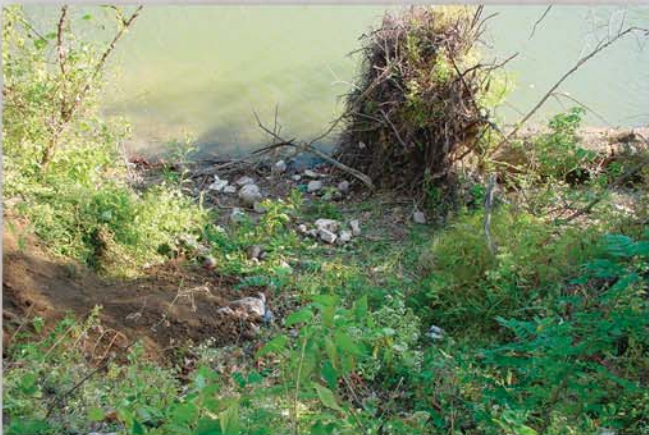
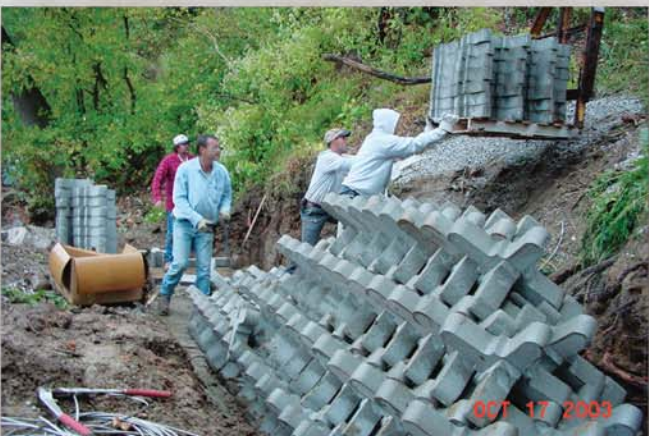
In February of 2003 strong storms and record water levels were experienced on the Kentucky River in downtown Frankfort Kentucky. The result of the damage left from this event was the total dislocation of a large sycamore tree on the bank of the river. This 150 foot tall, five-foot trunk diameter tree weighted over 12 tons after being sawn 10 feet from the root ball. The cavity left by its removal produced certain future structural damage on an adjacent city-parking arcade.

Frankfort Public Works Director Bob Tillet chose A-Jacks to solve the future erosion of the 1:1, 90-foot long embankment from the river to the parking lot above. A local contractor was called and in turn hired a sub-contractor to do the installation. The tree was first removed from the affected area and a receiving trench in preparation for the 4-3-2-1 engineered matrixes of A-Jacks. Filter fabric was laid on a 12-inch bedding layer of #57 crushed stone and then the A-Jacks were placed. The entire project took three days of which the Jacks portion represented 7 hours including backfill of #2 stone behind the Jacks and 12 to 18-inch riprap up the entire slope. The receiving trench was manually backfilled with native soils from the trench excavation. The city was pleased to see how easily and efficiently the Jacks went in and are anxious to see how well they perform. Overall cost for this successful project was \$31,000 with the A-Jacks and stone representing approximately \$4,700.
